Existing Conditions Analysis

The City of Los Altos
Community Center Master Plan

ANDERSON BRULÉ
ARCHITECTS, INC.

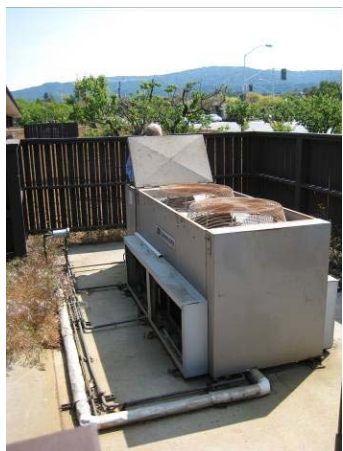
The existing system is 30 years old and all the equipment has exceeded its useful life. The energy usage is high due to low efficiency of the equipment and other building components. With any remodel or expansion of the City Hall, HVAC System and its equipment should be considered a priority in replacement and upgrade.

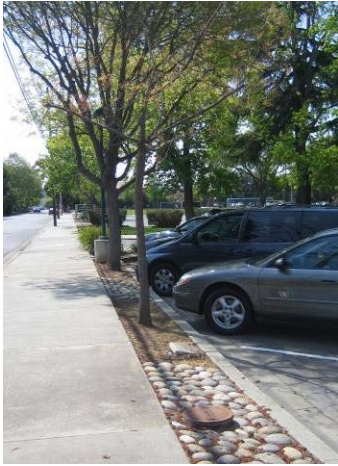
Insufficient planter width for proper car overhang

Improper drainage at west drop-off area.
Tree cut-out undersized.

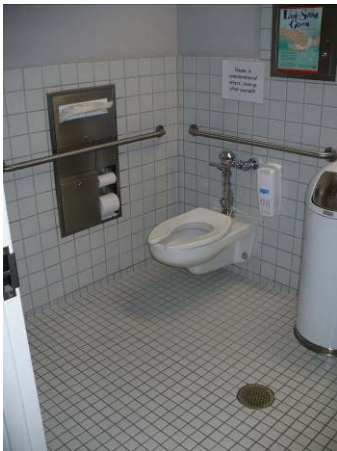
The Library has a Women’s Public Restroom, Men’s Public Restroom, Staff Unisex Restroom, Break Room, Janitor’s Closet, and Program Room which all have plumbing fixtures. Both the Women’s and Men’s Public Restrooms have one toilet that is ADA compliant, and all fixtures seem to be in good working condition. The Staff Unisex Restroom appears to have ADA compliant fixtures, which seem to be in good working condition.

A small electric point-of-use water heater, located under the Break Room sink, currently serves the Staff Unisex Restroom and Break Room, and is not providing sufficient hot water to either location.

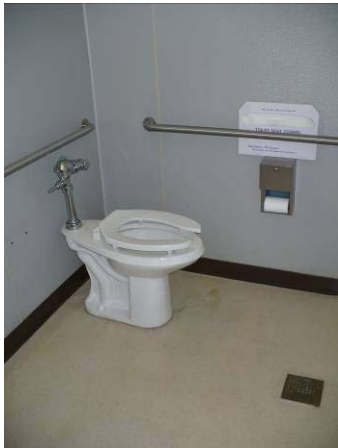
The Unisex Restroom's interior seems to be newer, and fixtures are presently working/adequate, however should be replaced when building renovations are done. The fixtures in the Men's Restroom are also presently working/adequate, but should be replaced when building renovations are done.

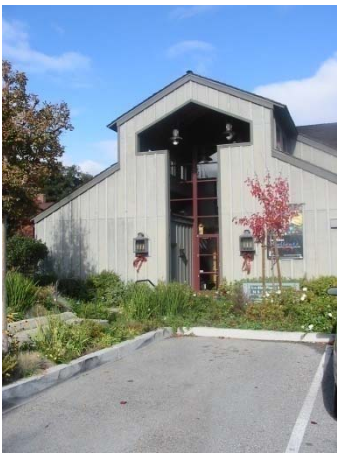
The re-configured parking lot adjacent to the History House and Museum is very well landscaped with a variety of planting materials, including Ornamental Pear trees, Japanese Maples and a large variety of flowering shrubs, perennials, and annuals that provide rich colors throughout the year. The planting strip between the sidewalk and parking lot provides a good separation from the vehicular traffic. Flagstone pavers provide easy access from the parking lot to the sidewalk and preserve the plant materials. The Ornamental Pears provide shade for the parking lot and provide beautiful spring blossoms and fall colors. The landscape creates a garden-like setting landscape on either side of the meandering concrete sidewalk, which makes the walking experience more enjoyable.

The post top pole lights along the parking should be updated with a more energy efficient model.
