MASTER PLAN

REDWOOD GROVE

NATURE PRESERVE

LOS ALTOS
CALIFORNIA

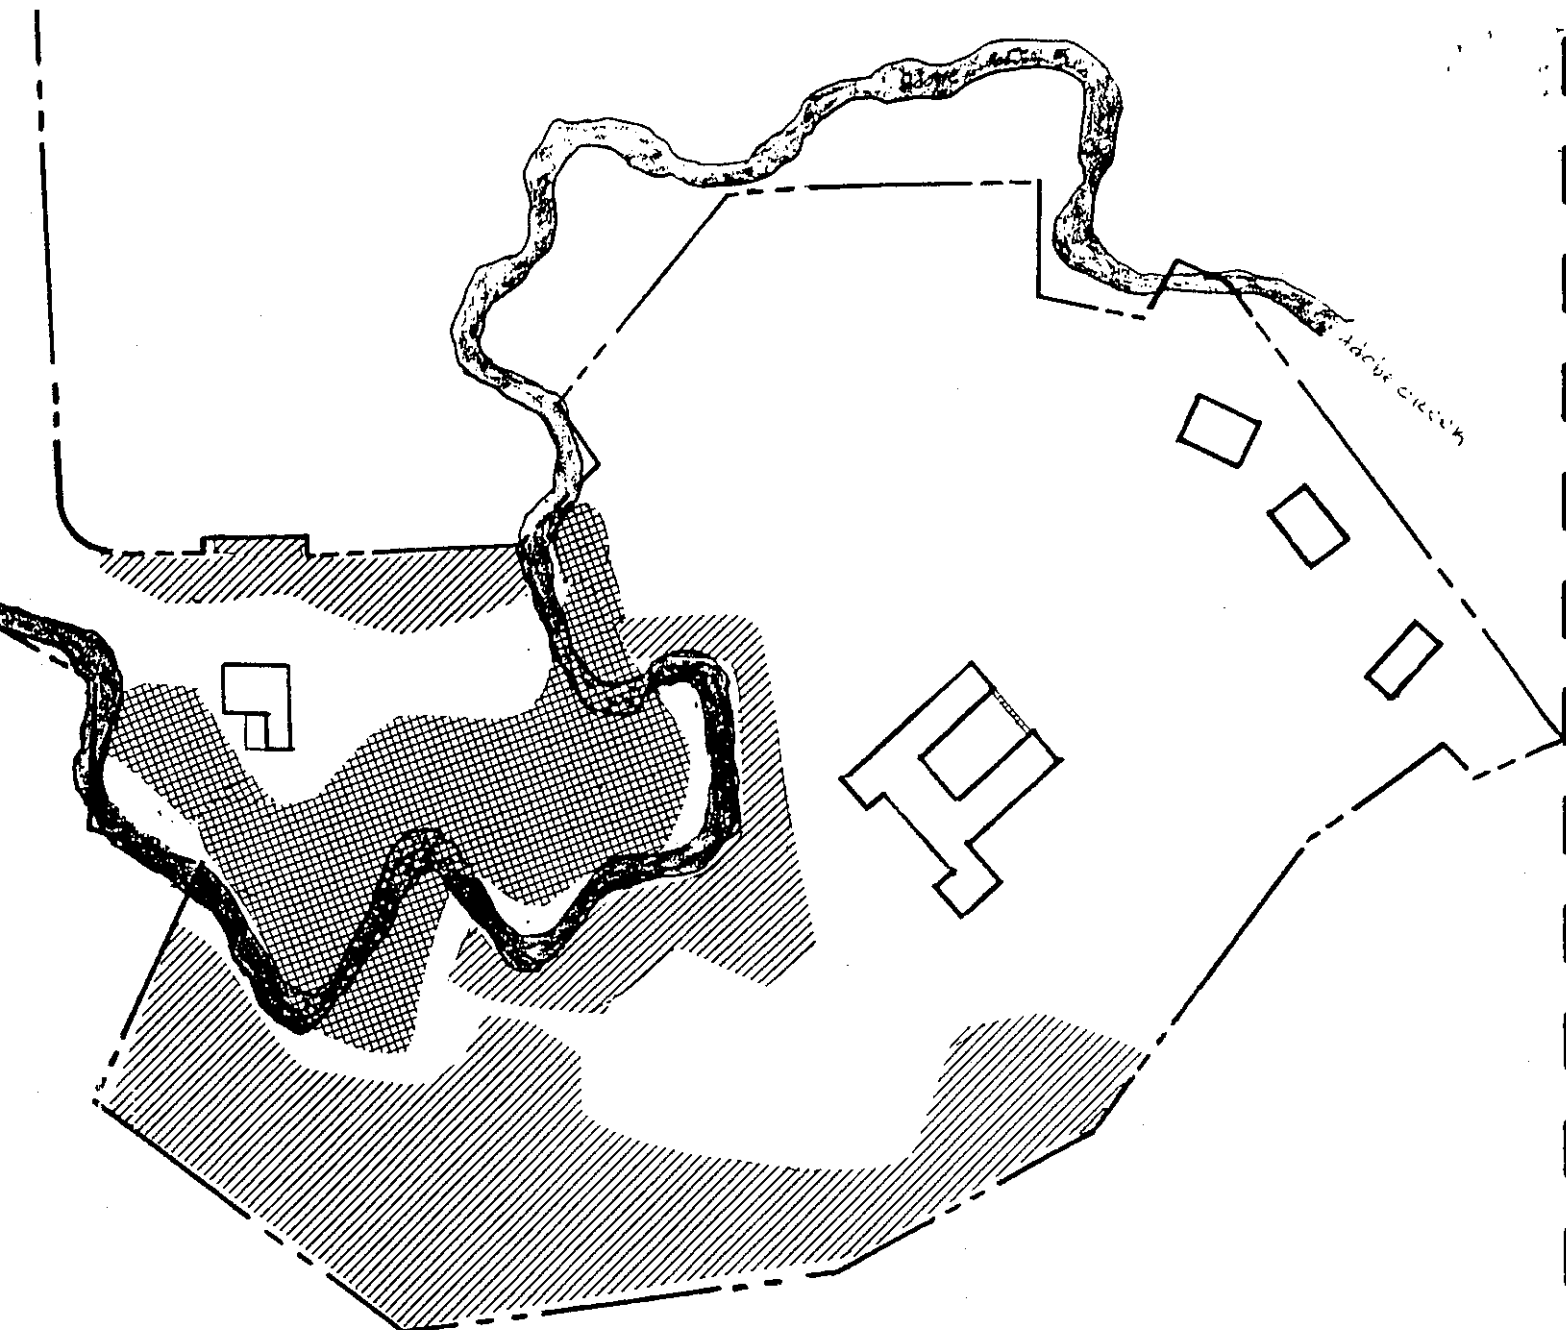
RESOURCES

ADOBE CREEK
 -

REDWOOD GROVE
 -

OAK/WOODS
 -

SCATTERED TREES + GRASS
- 3

the resources

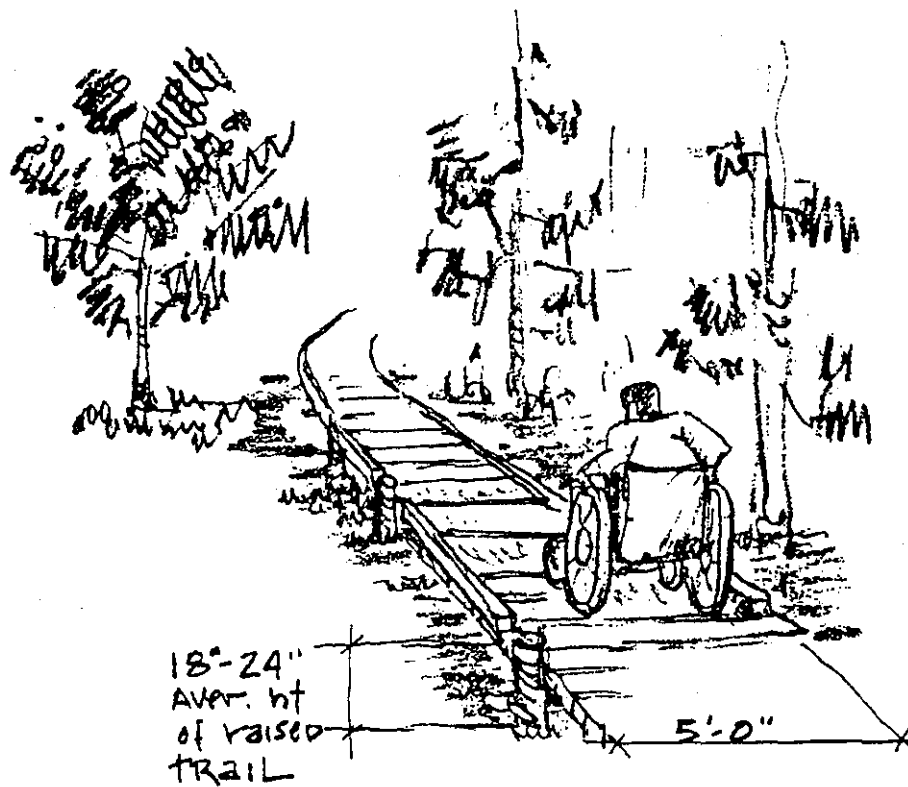
RAISED REDWOOD GROVE LOOP TRAIL

The area should include a self guided nature trail with observation sites. A portion of the trail should be hard surfaced to accomodate the handicapped. Also a trail should be into an area that would be "zoned" as a quiet/observation area - with a portion of such a trail being elevated.

Pave Loop Trail Segment (2" asphalt)	370' x 5'	5.00 l.f.	1850.00	
Construct Raised Deck Trail	460' x 5'	30.00 l.f.	13800.00	
Erosion Control				
Soil Bags	200	2.00	400.00	
Soil	45 c.y.	5.00	225.00	
Plantings				
Trees	20	35.00	700.00	
Shrubs	25	15.00	375.00	
Ground Cover	200	.50	100.00	
		Sub Total	17450.00

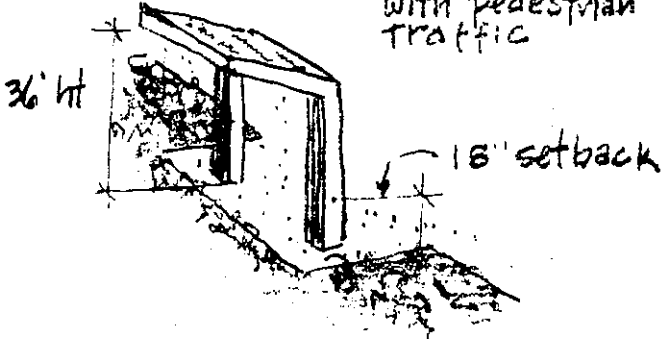
INFORMATION/INTERPRETIVE SIGNS

raised letters are helpful for the blind

signs should never interfere with pedestrian traffic
