Existing Conditions Analysis

The City of Los Altos
Community Center Master Plan

ANDERSON BRULÉ
ARCHITECTS, INC.

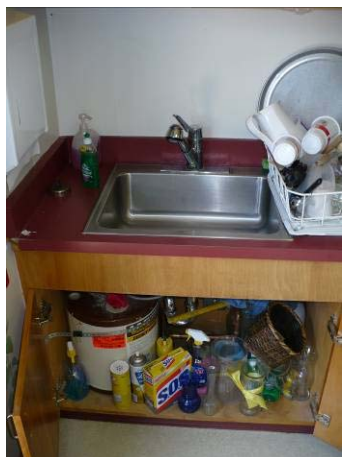
City Hall has five Restrooms, two at the City Chambers end, two in the hallway just south of the City Council Chambers, and one in the hallway, which is in the middle of the building. One of the two restrooms south of the City Council Chambers seems to have ADA compliant fixtures. All restroom fixtures are currently working adequately, but should be replaced when building renovations are undertaken. The Break Room has a stainless steel single compartment sink, garbage disposal, refrigerator, and a small tank water heater under the sink. The Break Room fixtures seem to be in good working condition.

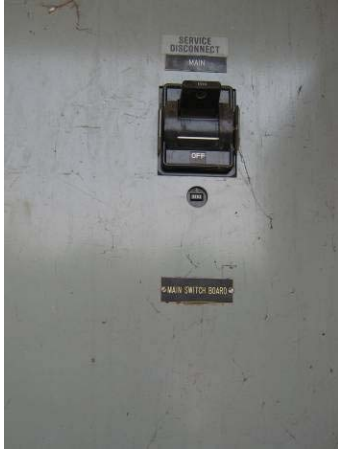
mechanical equipment, lighting and all devices and equipment requiring power. An existing 50KW diesel emergency generator provides emergency power to selected loads and areas throughout the facility. The existing lighting is generally provided by T12 fluorescent fixtures and controlled by local dual level switches in private offices and open areas through a switch bank. The City Chambers and a limited area have the more energy efficient T8 fluorescent fixtures. There is no exit and egress lighting. The panel boards do not have any spare circuits. There are several smoke detectors and audio alarms but no ADA required strobes and audio/visual alarms. The lighting system does not have auto-shut-off, an override switch or programmable time switch required by the current energy code. The electrical service capacity is sufficient for the operation of the existing facility and may support minor modifications. A major modification will require a closer study to determine if an upgrade in service will be necessary.

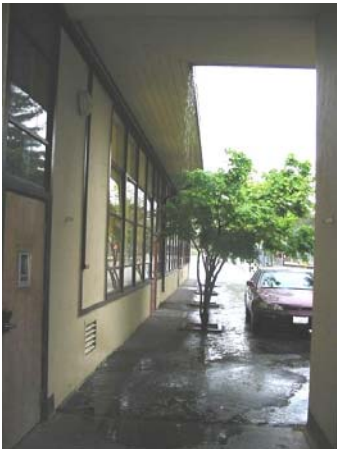
It was observed that the existing buildings at Hillview Community Center have outlasted their intended beneficial use. The materials, windows, doors, plumbing fixtures, HVAC and structural components show signs of significant deterioration. The spaces around the facility are wasteful underutilized, and seem isolated from the rest of the services on the site.

Due to the age of the facility, a series of comprehensive tests should be performed by a qualified and licensed abatement company to determine the presence, if any, of carcinogenic building materials (asbestos, etc.).

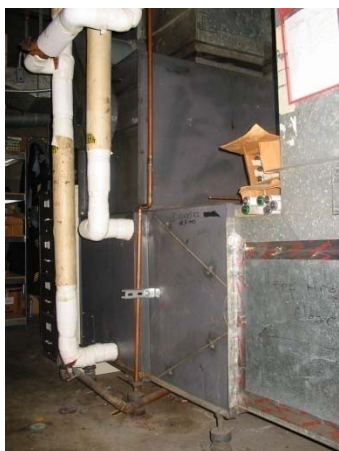
The Police Department building dates from 1958 with renovations and additions in 1967. The HVAC system consists of a Train air cooled chiller located on the outside concrete pad, piped to the air handling unit in the mechanical room in the basement. The chiller has nominal capacity of 20 tons.

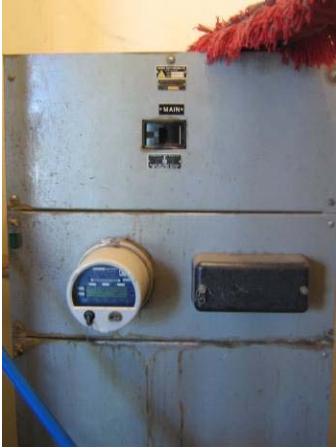
The electrical equipment are operational and at the end of its life expectancy. Any minor modification will require an upgrade in electrical service size. The lighting system does not have auto-shut-off, an override switch and programmable time switch required by the energy code.
